ENERGY AUDIT REPORT

360 Grove Street
Somerville, NJ
08876

DeFeo Associates

March 1, 2010

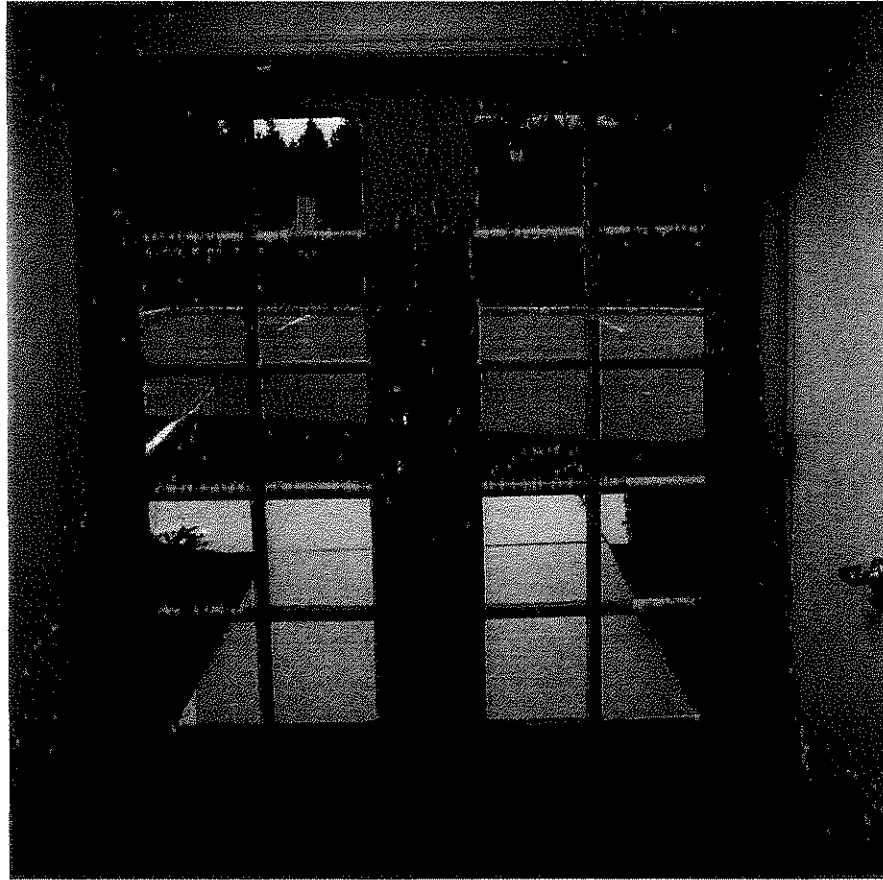
There are three door systems in the building; two on the north side of the building and one, the main entrance, on the south side of the building. Two of these entrances have an airlock system in place that allows for greater retention of conditioned air. However, the rear entrance is a simple double door that lacks any thermal protection. This door allows for substantial heat loss in the winter and heat gain in the summer. In addition, the door allows for increased drafts to enter the building and negatively effects worker comfort.

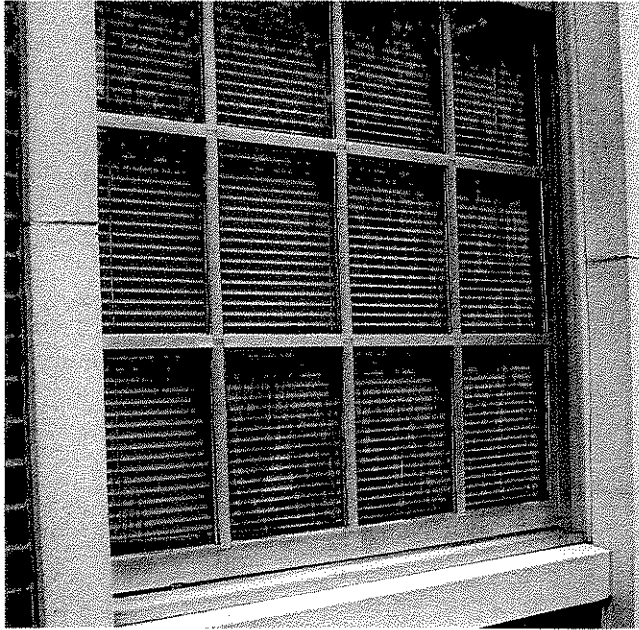
The original building has old style, poorly designed thermal windows. These windows have metal frames and lack thermal breaks in their construction. Accordingly, they demonstrate poor thermal protection. In addition, many of the window seals have failed. This results in condensation between the panes and increased thermal conductivity.

Note condensation in window frame

Windows: The current windows in some areas of the building provide very little insulation due to their age and condition. The windows could be replaced with sealed double-pane windows with thermal breaks.

Consider the installation of thermal window treatments that allow for sealed tracks. Train staff in their use and monitor on a continuous basis. This is a much lower cost alternative to new windows and the treatments can be moved to a new location when needed.

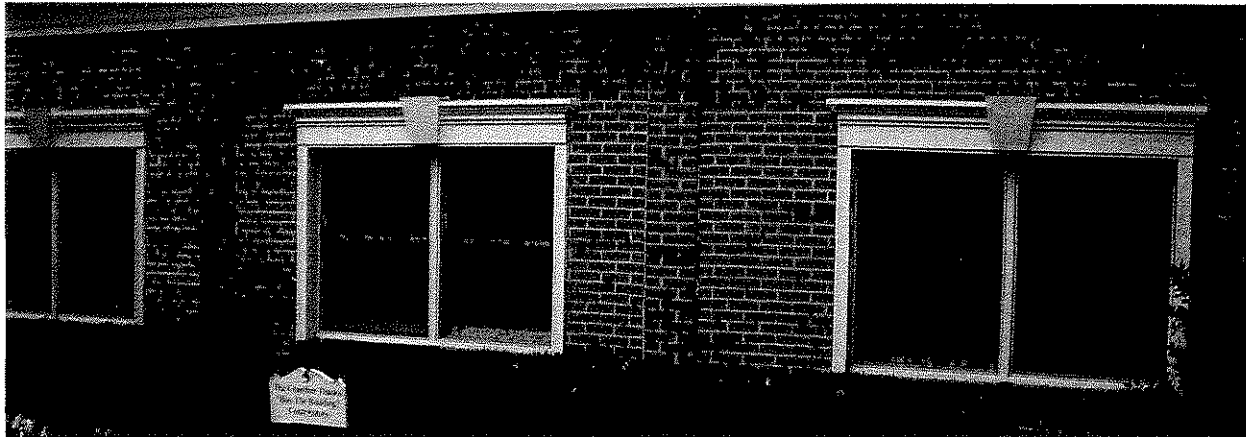
The newer portion of the building contains thermal windows that are of a more recent design. However, staff indicates that these windows have significant drafts present.

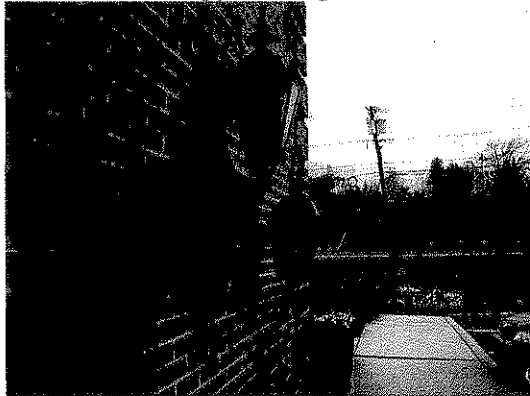
Outdoor building lighting consists of incandescent light fixtures attached to the building. The bulbs in these fixtures can be easily replaced with compact fluorescent bulbs to enhance energy savings.

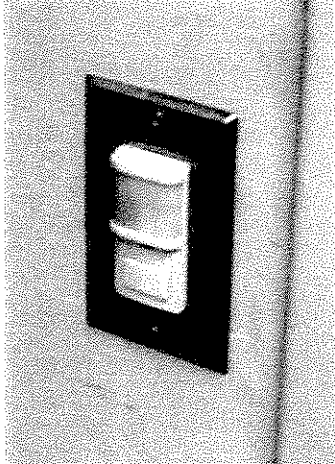
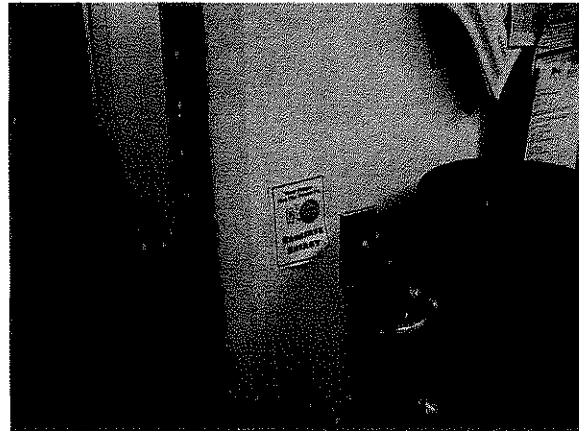
Manual controls often fail due to individual behavior. Note the sign below and the fact that although the room was not occupied, the lights were left on. Motions sensors would prevent this waste of electricity.

Either engage in employee education at no cost to reduce lighting consumption, or install occupancy sensors in each of the above areas.

Installation of motion sensors in these areas can help reduce lighting costs by over 30%, or more than \$660 each year. Paybacks for motion sensors are typically under three years. Total motion sensors required: 10+/-

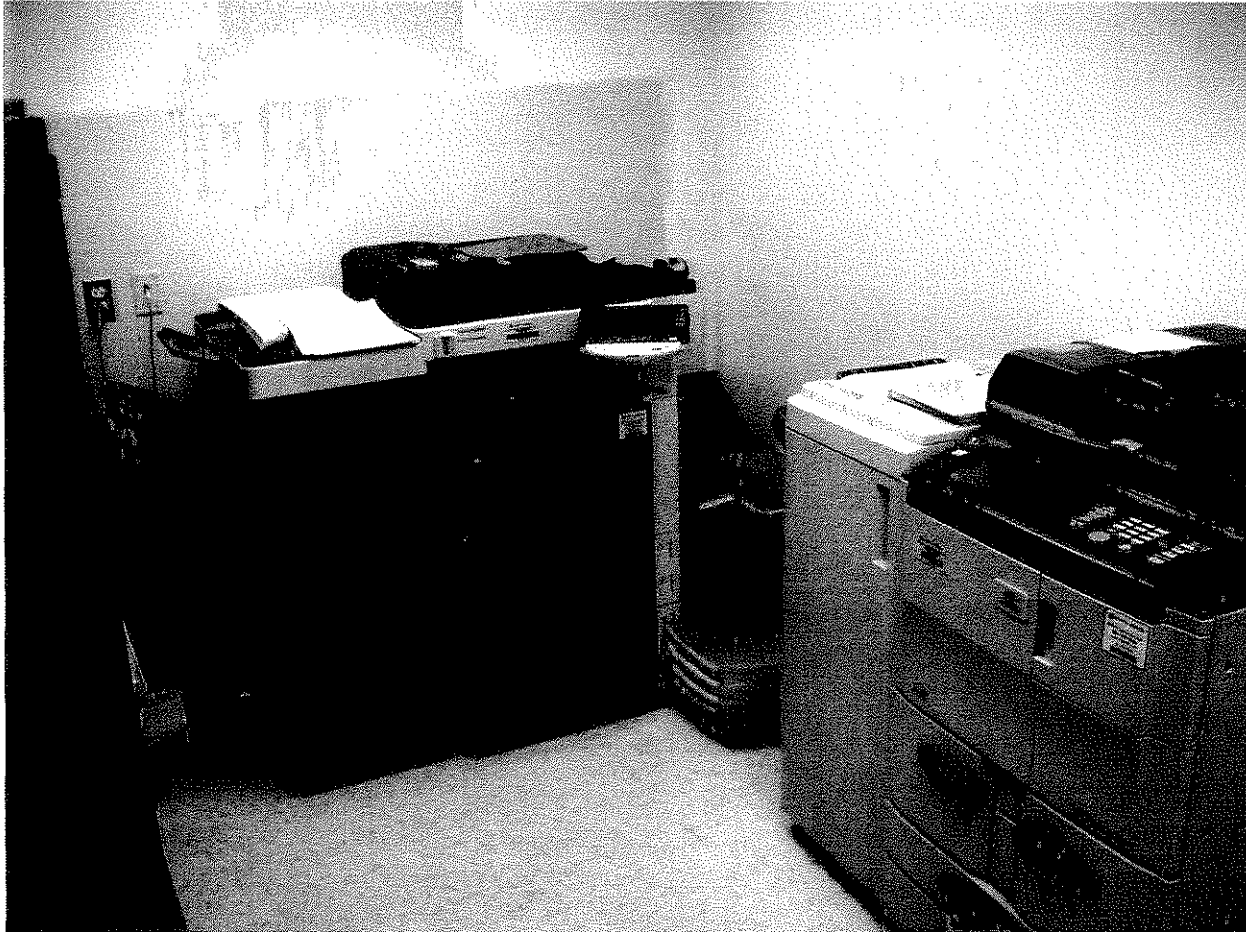
The majority of the equipment is located in the business hub portion of the office. This space is a small room with copiers and large - scale printers.

Although much of the equipment is Energy Star rated, not all is so listed. Specifically, it does not appear that at least one printer several of the computer monitors are not Energy Star rated.

Insure that all office equipment purchased is Energy Star Rated. Also, instruct staff to turn all equipment off when they are leaving the office for extended periods.

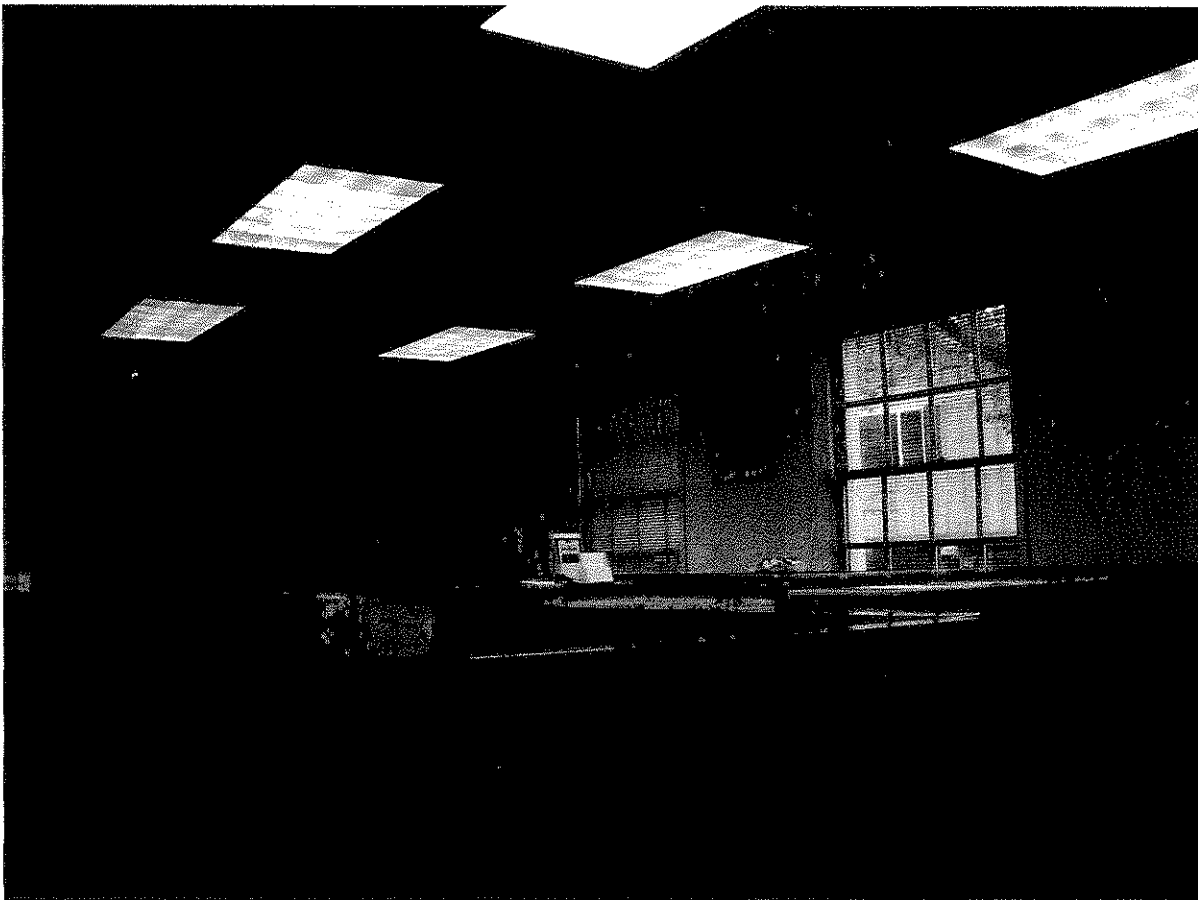
Each wall of the building has large windows that provide over 30 square feet of natural day lighting per window. Unfortunately, the current cubicle configuration in the open areas impedes accessibility to this light.

Improve day-lighting distribution by reconfiguring cubicle layout and removing obstructions to windows. Utilize appropriate shading technology where needed to reduce solar heat gain while allowing natural light to enter the building.

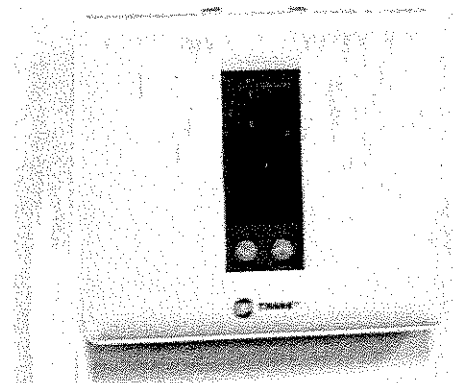
Thermostats Although the building is equipped with programmable thermostats, it was evident during the audit that each of the thermostats was set for a twenty-four hour heating cycle seven days per week at a constant temperature. This not only causes the heat to operate all of the time, it requires that the building be heated when it is not occupied. While surveying the building, it was found that building occupants had changed many of the settings on the thermostats.

In addition, the air conditioning system was engaged simultaneously during the heating season. This requires the air conditioning system to operate on warm winter days when the system is not actually needed to provide a comfortable work environment, as the setting is an arbitrary number on the thermostat.

Complete resetting all thermostats to reflect occupancy use within the building. Educate staff as to the effect of improper thermostat use. Engage the heating system during the heating season and the air conditioning system during the cooling system only.

If necessary, install thermostat locks to prevent unauthorized access to the temperature settings.

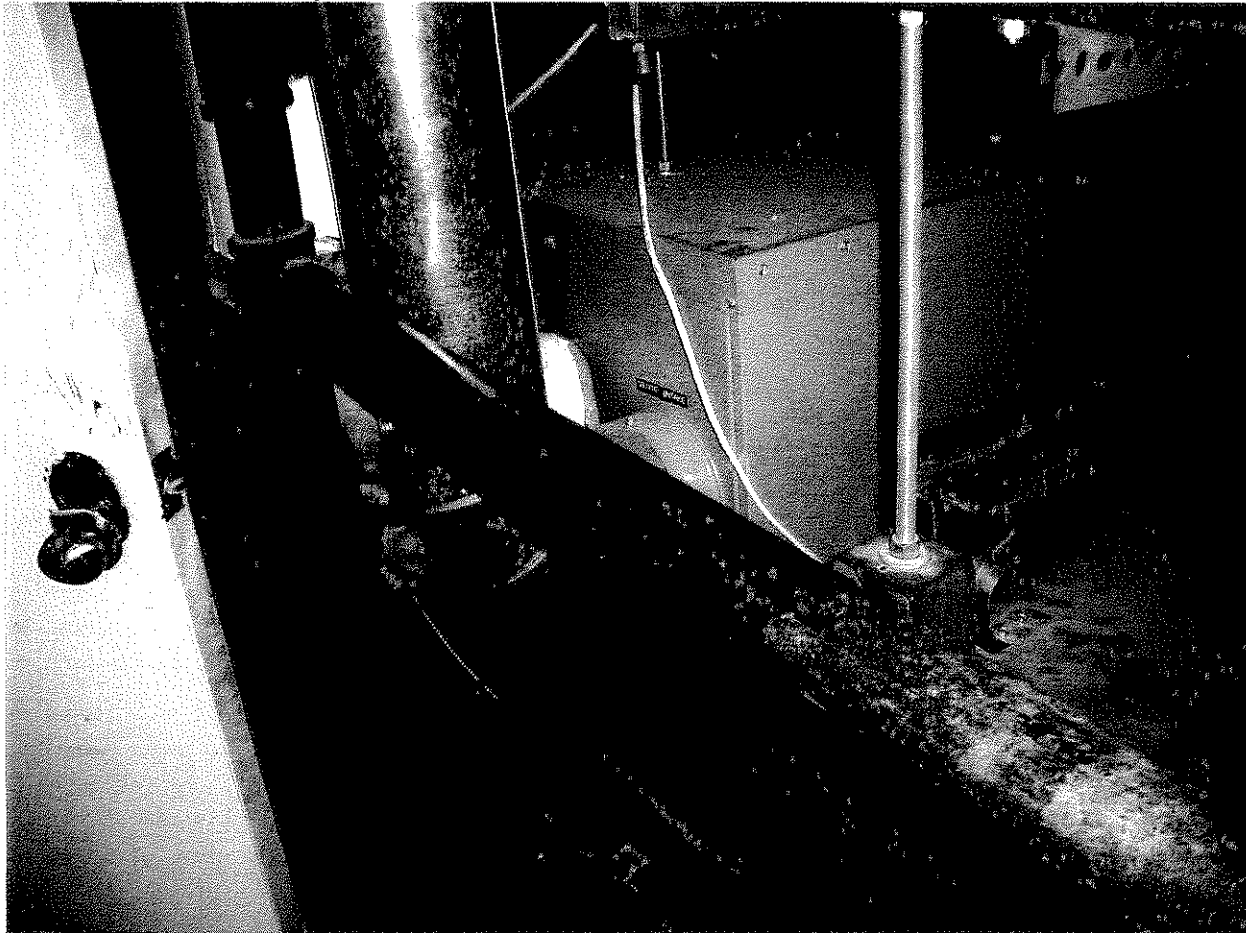
The building is served by a single gas fired forced hot air heating system. The unit appears to be approximately 20 years in age. Based on the age and appearance of the unit, its estimated efficiency is less than 70%.

Furnace Replacement. The existing furnace is more than 16 years old and is a relatively low efficiency unit.

Remove the existing furnace and install a new smaller, high-efficiency Furnace. However, this improvement falls outside the scope of tenant actions. The Tenant should consult with the building owner to determine whether the owner will assist in this matter.

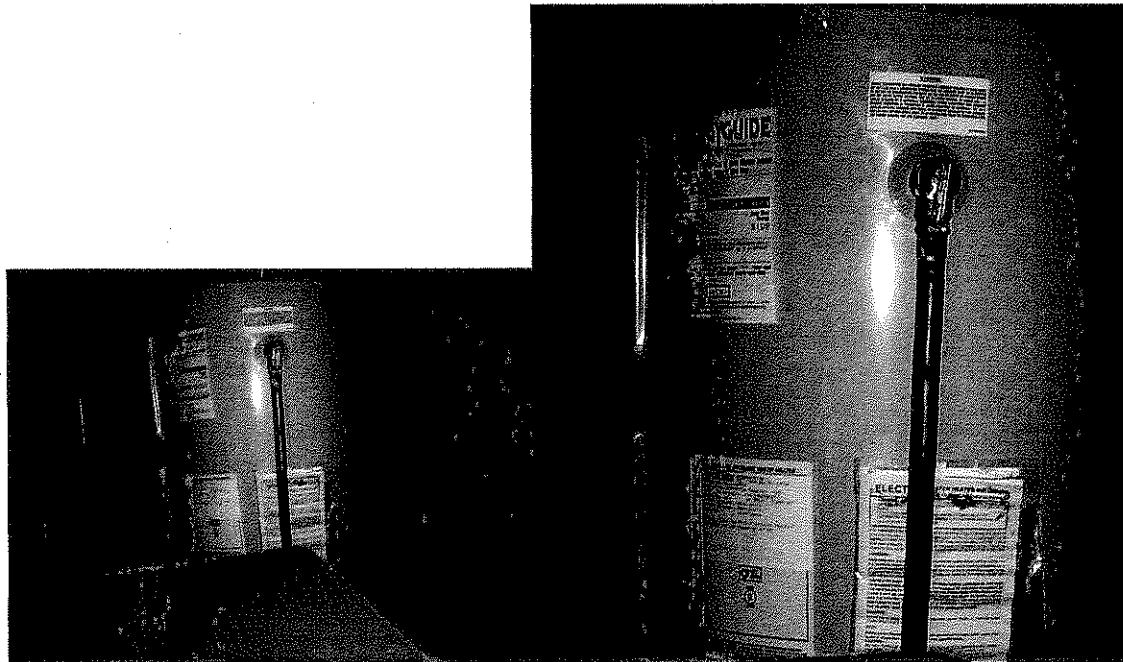
Hot water is currently supplied by an electric hot water heater located in the mechanical room on the second floor of the building. The unit is not insulated, nor are the pipes in the space insulated.

Based on the unit's energy label, its projected electric consumption is 4933kwh per year. This is relatively inefficient unit.

This unit should be heavily insulated and the pipes leading from the unit should be insulated to prevent standby heat loss.
